**Subject: Roof Assessment and Budget Proposal for 741 4th Street**

# Inspection Report

RCGH, Inc.  
733 4th St  
Santa Rosa, CA 95404

## Silver Coated Capsheet

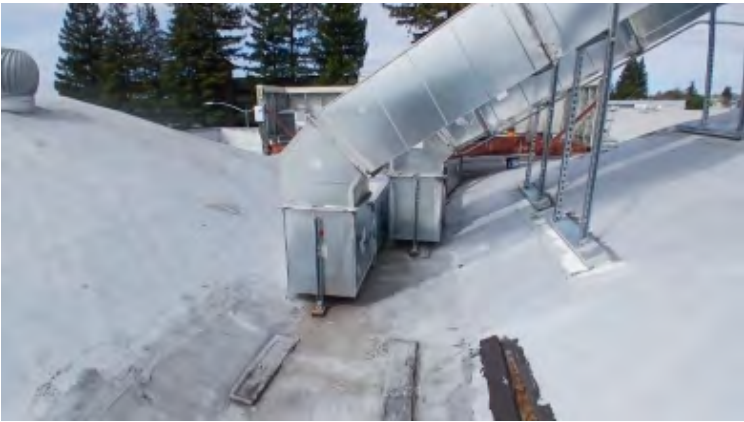
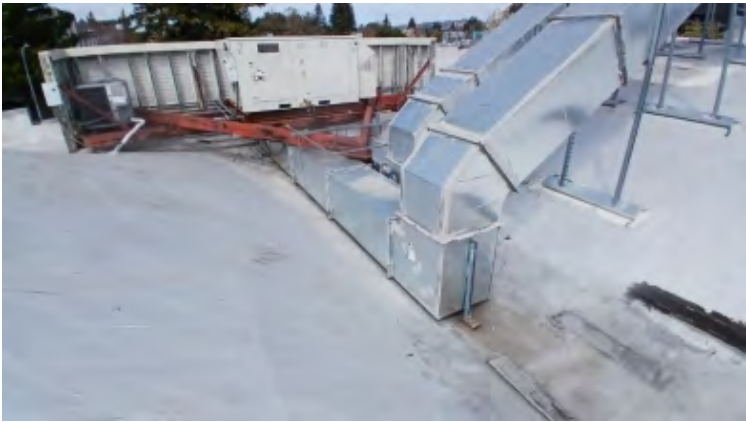
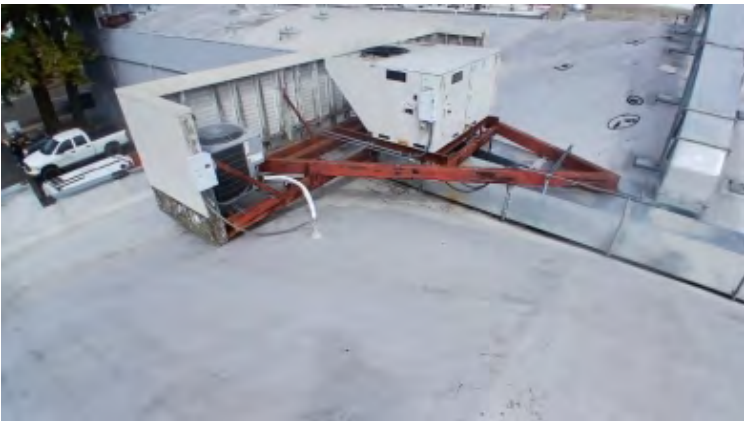
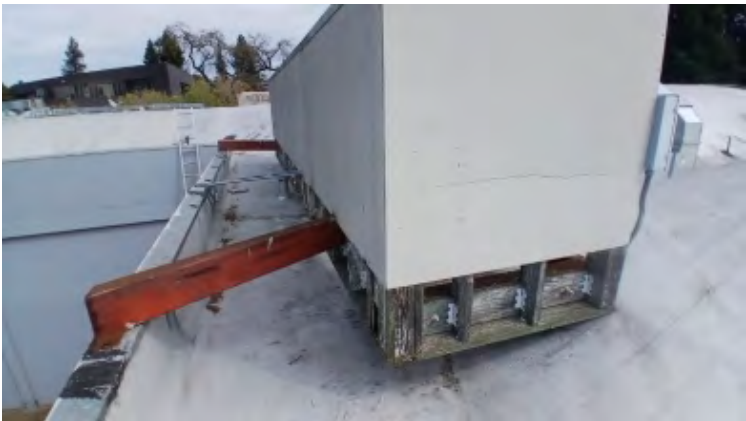
**Overhead Obstruction**

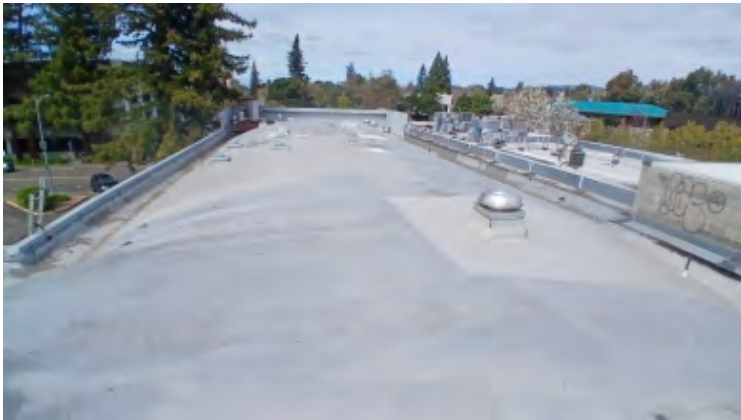
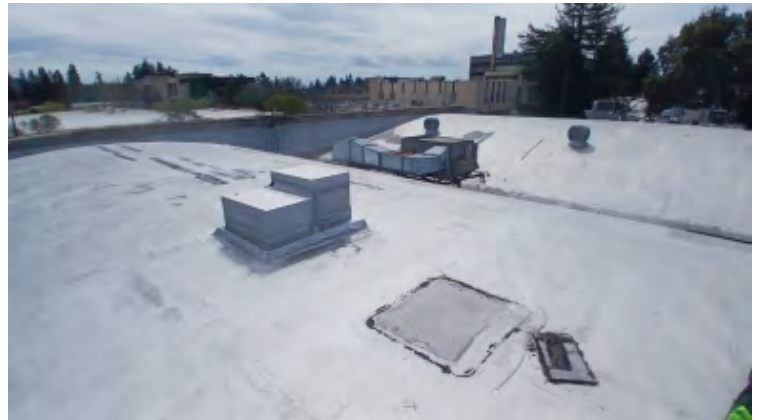
**Staging Locations**

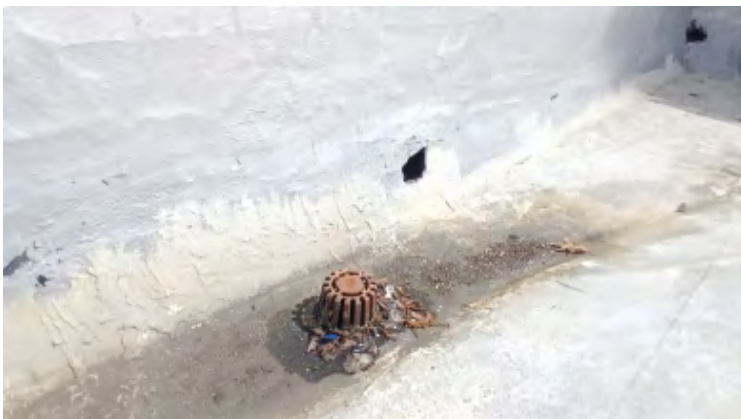
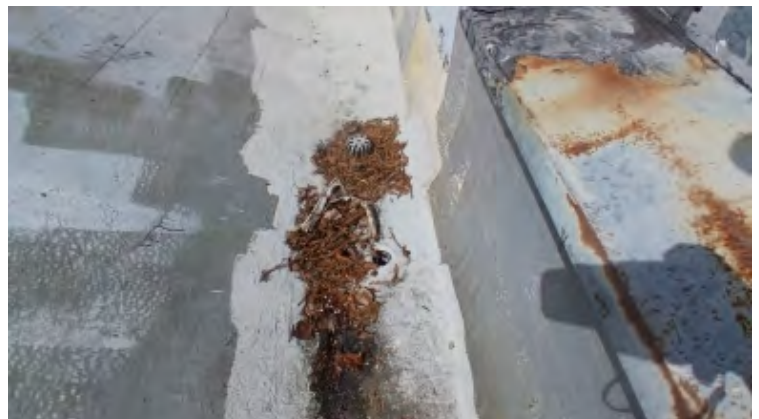
**Drains/Overflows/Scuppers**

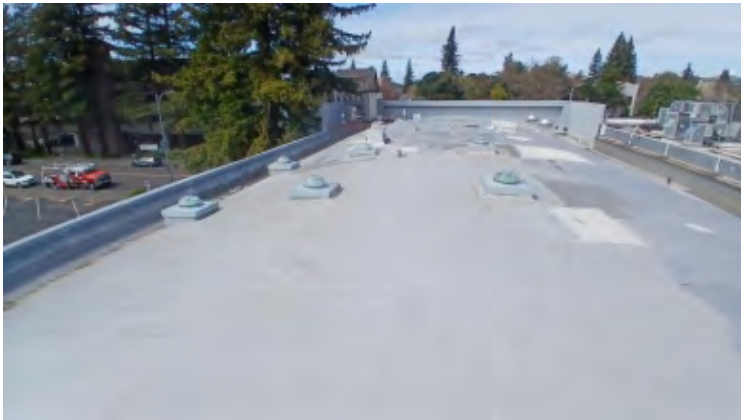
**Sun Tunnels**

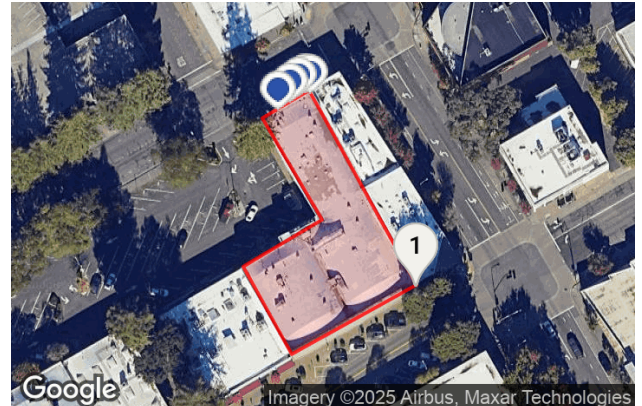
### 04a - Open Parapet Transition (Emergency)

Parapet transition is open, deteriorated or has a hole

Loose aluminum coating and heavy aluminum pigment should be removed completely and cleaned. Any wet areas must be removed and/or dried out before coating.

Repair all cracks, voids, or other surface imperfections in the roof field or flashing areas with acrylic mastic and polyester fabric. The polyester fabric shall extend 4-6 inches beyond the area in need of repair.

Apply Prime-Tek Epoxy Primer at ½ gallon per 100 square feet as needed over aluminum coating.

Apply Henry PG 294 or AcryShield 400 as base coat at 1.25 gallons per 100 square feet over BUR.

Mix in High high-performance microfibers with Acrylic thoroughly to create seam seal.

Apply Henry Pro-Grade 988 silicone coating at 30 mils DFT, approximately 2.0 gallons per 100sqft.

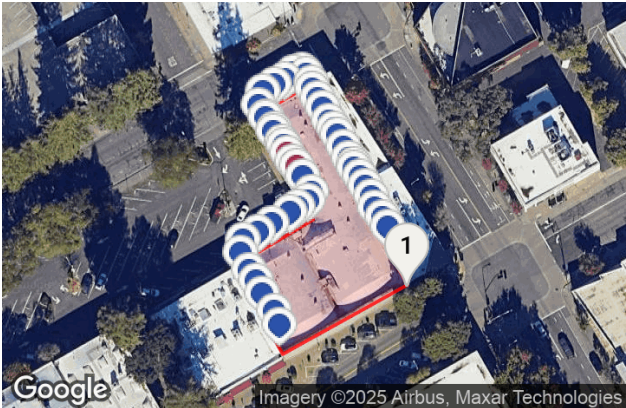
**02 - Cap Metal Joint Deteriorated/Split/Open (Emergency)**

Cap Metal is deteriorated, split or open. This could lead to leaks and/or damage to the parapet  
8ft step ladder will be needed

Cap metal seams.  
Clean the surface with a wire brush. Apply M-1 sealant under cap metal seams and resecure with rivets.

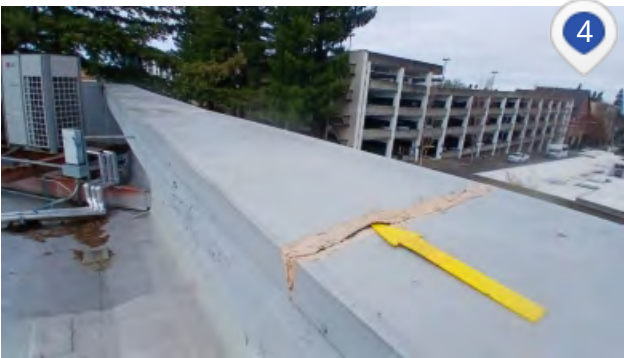
**03 - Fastener Backout (Emergency)**

Fasteners have backed out  
70 LF of cap metal is loose.

Remove backed out fasteners and install new ones (larger size may be needed)  
50 screws

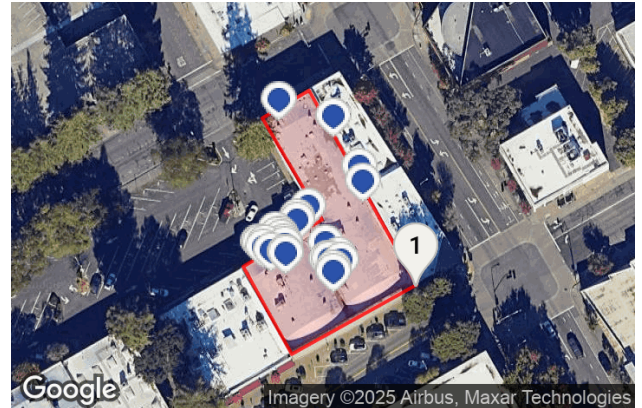
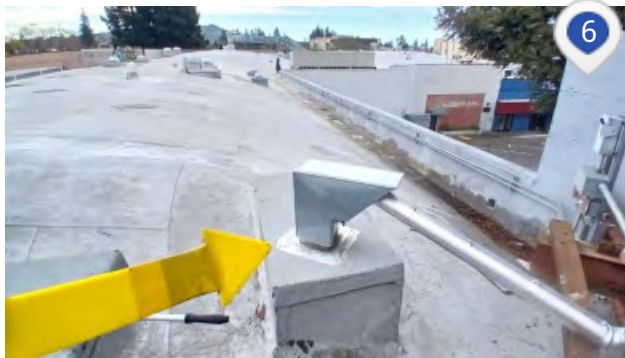
### 06g - Deteriorated Flashing Penetration (Emergency)

The flashing penetration is deteriorated and should be repaired immediately

Loose aluminum coating and heavy aluminum pigment should be removed completely and cleaned. Any wet areas must be removed and/or dried out before coating.

Repair all cracks, voids, or other surface imperfections in the roof field or flashing areas with acrylic mastic and polyester fabric. The polyester fabric shall extend 4-6 inches beyond the area in need of repair.

Apply Prime-Tek Epoxy Primer at ½ gallon per 100 square feet as needed over aluminum coating.

Apply Henry PG 294 or AcryShield 400 as base coat at 1.25 gallons per 100 square feet over BUR.

Mix in High high-performance microfibers with Acrylic thoroughly to create seam seal.

Apply Henry Pro-Grade 988 silicone coating at 30 mils DFT, approximately 2.0 gallons per 100sqft.

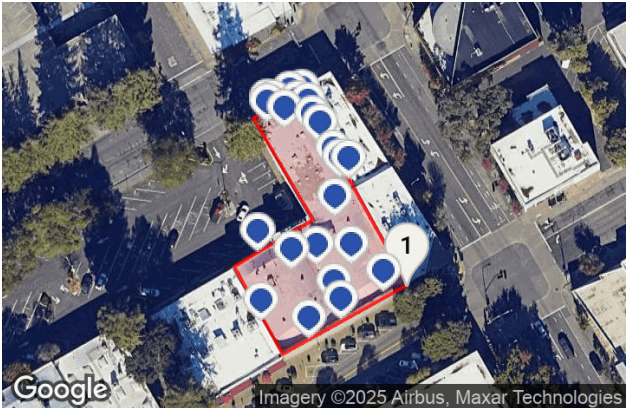
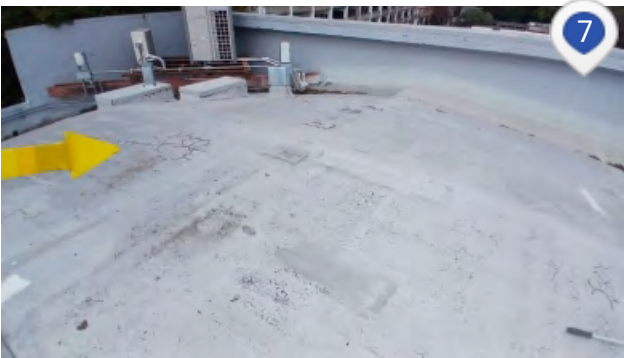
**08a - Deteriorated Field Membrane Silicone (Emergency)**

Field membrane is deteriorated. The suns UV rays will damage roofing membranes. Coatings can be applied to extend the service life of roofing membranes and work as "sunscreen protection"

Silver coating is deteriorated and cracking.

Loose aluminum coating and heavy aluminum pigment should be removed completely and cleaned. Any wet areas must be removed and/or dried out before coating. Repair all cracks, voids, or other surface imperfections in the roof field or flashing areas with acrylic mastic and polyester fabric. The polyester fabric shall extend 4-6 inches beyond the area in need of repair.

Apply Prime-Tek Epoxy Primer at ½ gallon per 100 square feet as needed over aluminum coating.

Apply Henry PG 294 or AcryShield 400 as base coat at 1.25 gallons per 100 square feet over BUR.

Mix in High high-performance microfibers with Acrylic thoroughly to create seam seal.

Apply Henry Pro-Grade 988 silicone coating at 30 mils DFT, approximately 2.0 gallons per 100sqft.

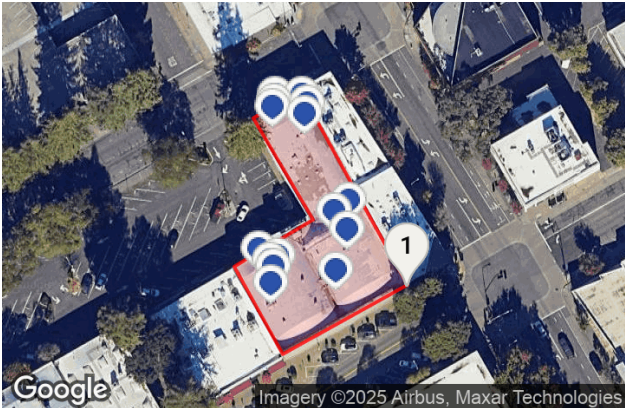
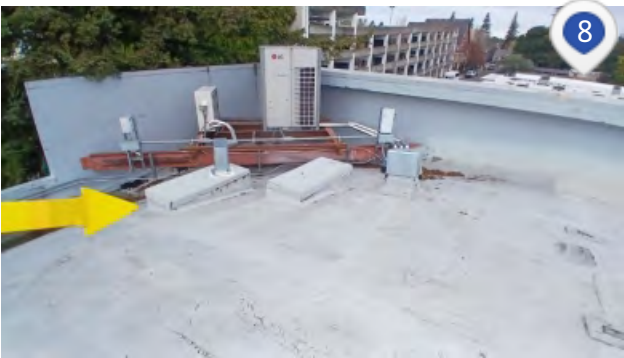
06e - Deteriorated Flashing Curb (Emergency)

The curb flashing is deteriorated and should be repaired to extend the service life of the membrane

Loose aluminum coating and heavy aluminum pigment should be removed completely and cleaned. Any wet areas must be removed and/or dried out before coating. Repair all cracks, voids, or other surface imperfections in the roof field or flashing areas with acrylic mastic and polyester fabric. The polyester fabric shall extend 4-6 inches beyond the area in need of repair. Apply Prime-Tek Epoxy Primer at ½ gallon per 100 square feet as needed over aluminum coating. Apply Henry PG 294 or AcryShield 400 as base coat at 1.25 gallons per 100 square feet over BUR. Mix in High high-performance microfibers with Acrylic thoroughly to create seam seal. Apply Henry Pro-Grade 988 silicone coating at 30 mils DFT, approximately 2.0 gallons per 100sqft.

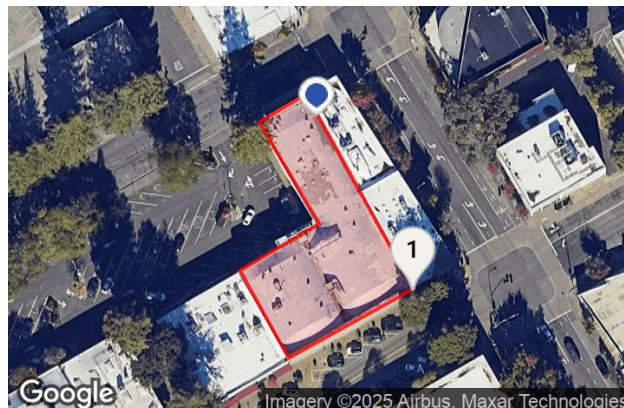
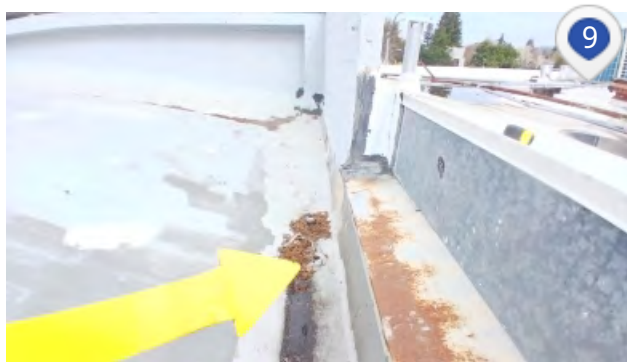
### 01fl - Drain Screen Broken/Missing (Emergency)

Drain screen is broken or missing. This could cause downspouts or drain pipes to clog and back up. Overflows need drain screens 4in

Snake drain before installing drain screen.

Replace missing/damaged drain screen with new

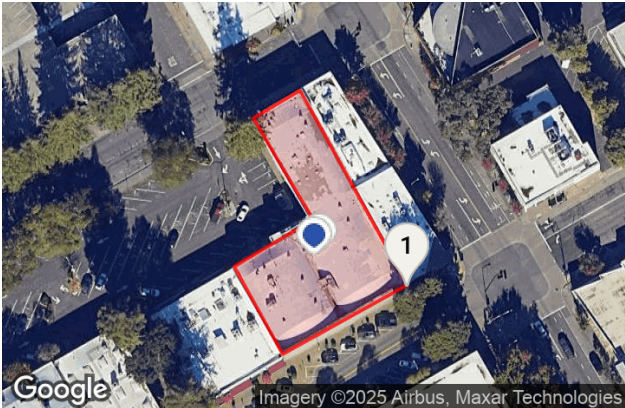
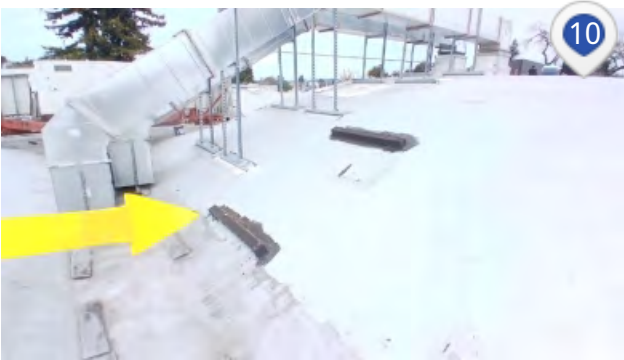
**07d - Failed Patch (Emergency)**

Existing repair(s) are failing due to age or improper repair

Loose aluminum coating and heavy aluminum pigment should be removed completely and cleaned. Any wet areas must be removed and/or dried out before coating.

Repair all cracks, voids, or other surface imperfections in the roof field or flashing areas with acrylic mastic and polyester fabric. The polyester fabric shall extend 4-6 inches beyond the area in need of repair.

Apply Prime-Tek Epoxy Primer at ½ gallon per 100 square feet as needed over aluminum coating.

Apply Henry PG 294 or AcryShield 400 as base coat at 1.25 gallons per 100 square feet over BUR.

Mix in High high-performance microfibers with Acrylic thoroughly to create seam seal.

Apply Henry Pro-Grade 988 silicone coating at 30 mils DFT, approximately 2.0 gallons per 100sqft.

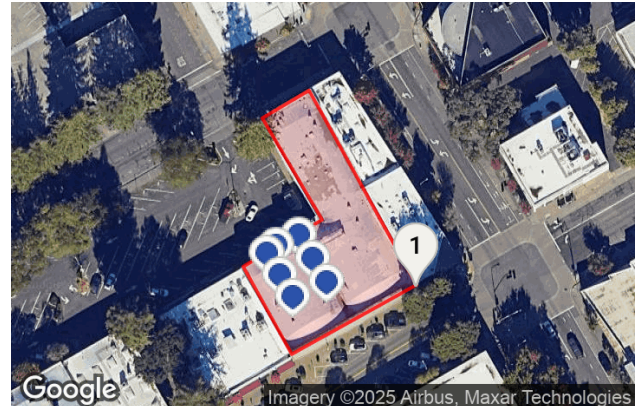
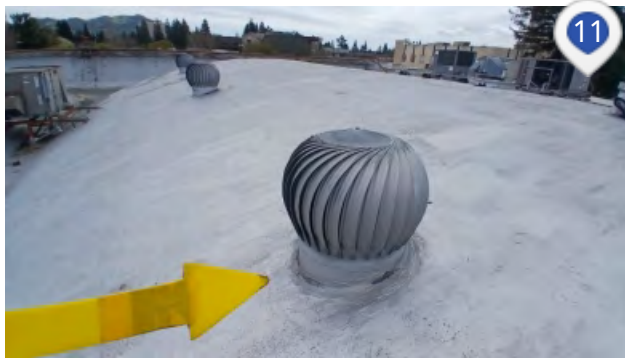
### 06g - Deteriorated Flashing Penetration (Emergency)

The flashing penetration is deteriorated and should be repaired immediately

Loose aluminum coating and heavy aluminum pigment should be removed completely and cleaned. Any wet areas must be removed and/or dried out before coating.

Repair all cracks, voids, or other surface imperfections in the roof field or flashing areas with acrylic mastic and polyester fabric. The polyester fabric shall extend 4-6 inches beyond the area in need of repair.

Apply Prime-Tek Epoxy Primer at ½ gallon per 100 square feet as needed over aluminum coating.

Apply Henry PG 294 or AcryShield 400 as base coat at 1.25 gallons per 100 square feet over BUR.

Mix in High high-performance microfibers with Acrylic thoroughly to create seam seal.

Apply Henry Pro-Grade 988 silicone coating at 30 mils DFT, approximately 2.0 gallons per 100sqft.

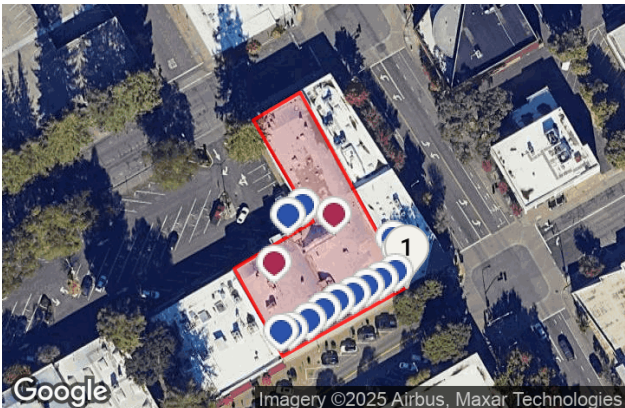
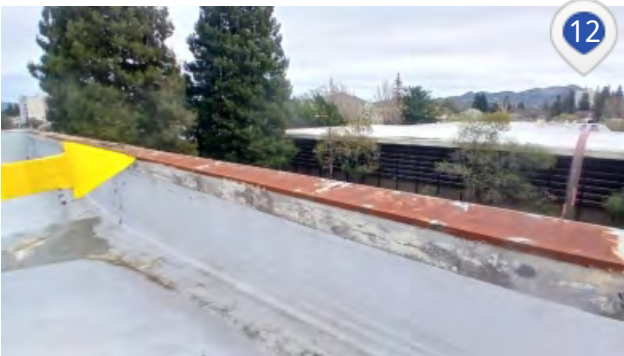
**02a - Deteriorated Sealant on Metal (Emergency)**

Sealant on metal has deteriorated or failed  
8ft step ladder needed.

Cap metal seams.  
Clean the surface with a wire brush. Apply M-1 sealant under cap metal seams and resecure with rivets. Replace any loose screws found and apply sealant.

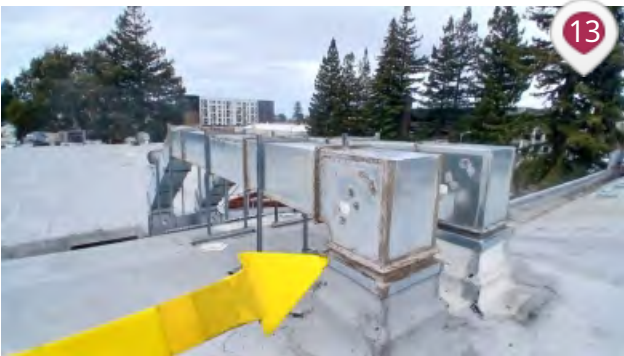
**10 - HVAC Ducting Deteriorated (Emergency)**

HVAC ducting is deteriorated and needs repair

Mechanically clean all HVAC seams and remove loose material.  
Apply rust inhibiting primer on subject rust duct seams.  
Clean and prep to receive coatings  
Apply High performance Acrylic gel to subject HVAC seams.  
Clean up jobsite and remove spent materials.
