## Conditions Assessment Report

### Santa Rosa – 741 4<sup>th</sup> Street

741 4th St.  
Santa Rosa, CA 95404  
ZFA Project: 25512.00

September 19, 2025

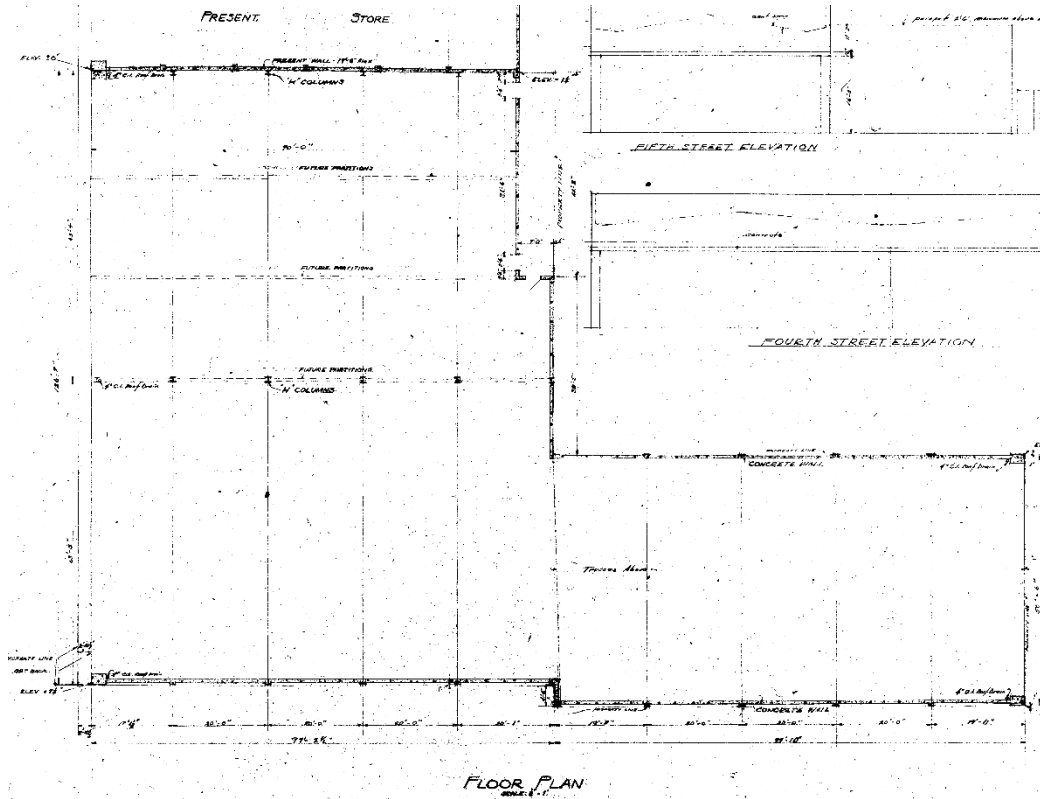
Plan 1: 1946 Original Construction Drawings Foundation Plan

- a. **BUILDING GEOMETRY:** The building was originally designed and assumed constructed as one structure. The tenant demising walls are non-structural. The floor plan includes varied geometry including re-entrant corner horizontal discontinuities. Multiple bearing and shear walls are utilized in the lateral force resisting system. Additionally, the interior frame and collector provide specific strengthening for the building at the re-entrant corner. *See Plan 1 & 3.*

**RECOMMENDATION:** Additional analysis of the system can be performed to review demand and capacity of the frames and critical concrete shear walls. Two specific items are primary concern:

- a. The retrofit frame added at the front of the building is likely the most critical lateral resisting element with low redundancy (one frame this line) and high demand (supports a significant portion of the building including main egress).
- b. The wall at the West end appears to be shared with the adjacent building. The original drawings indicate post and beam construction at the intersection and illustrate a positive lateral connection to this wall. Review the construction of the existing wall and determine adequacy. Low priority.

The remaining structure additional analysis is lower priority as the retrofit addressed the horizontal discontinuity issue.

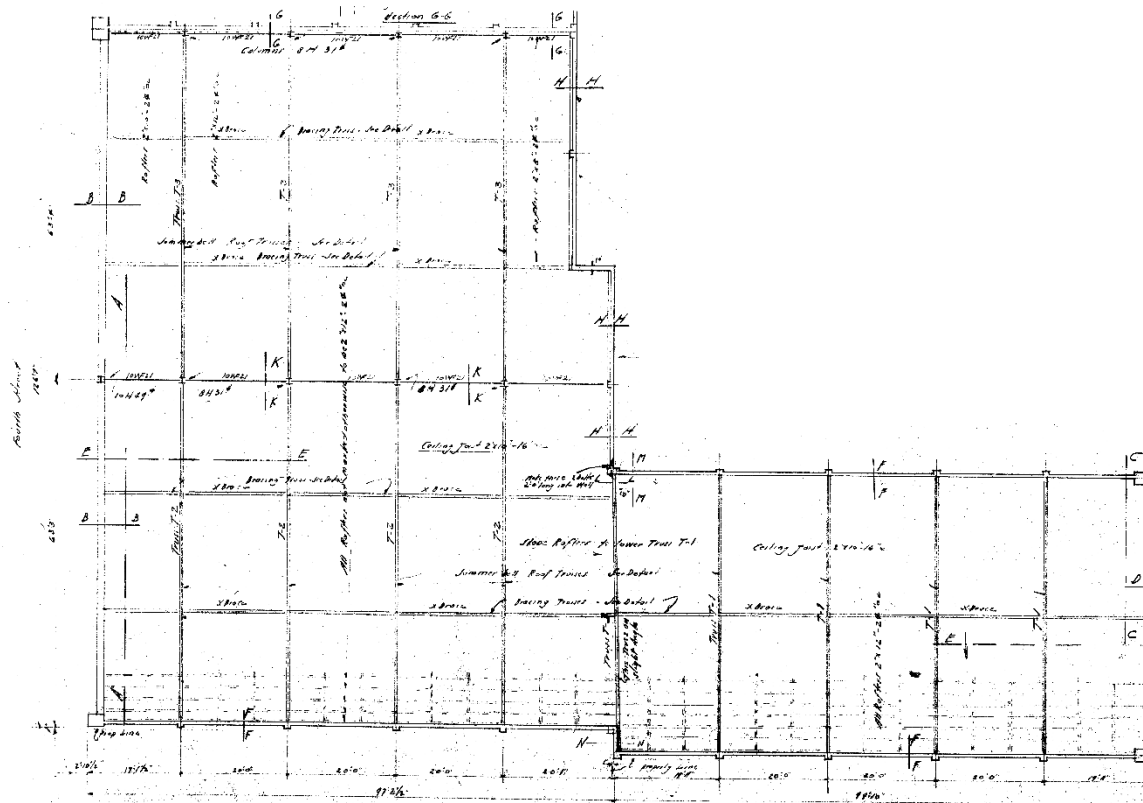
Plan 2: 1946 Original Construction Drawings Roof Framing Plan

- b. **DIAGONALLY SHEATHED DIAPHRAGMS:** The diagonally sheathed diaphragms have spans greater than 40 feet between resisting lines. The diaphragms may be overstressed for seismic loads. *See Plan 2*

**RECOMMENDATION:** Additional analysis is required to review the demand and capacity of the diaphragms. Generally, this is a low priority deficiency for this type of building.

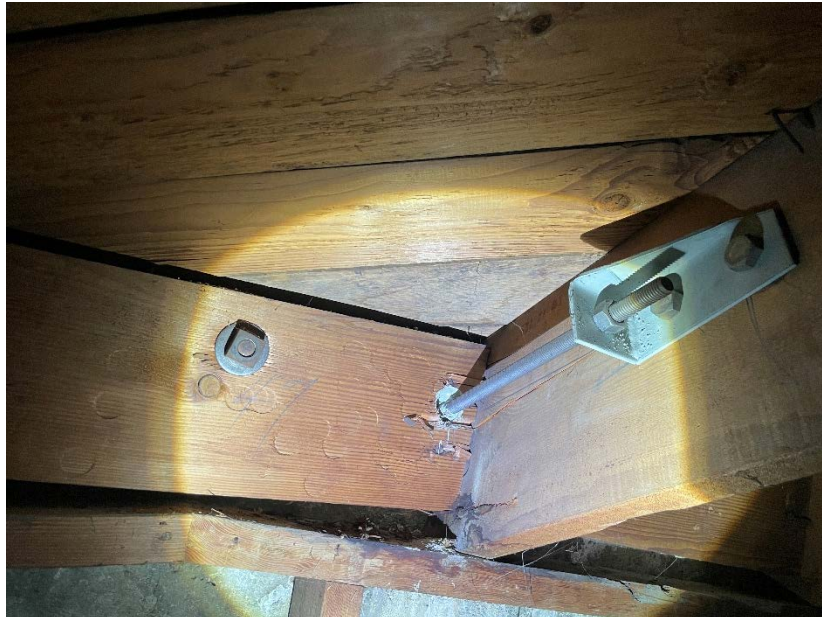
- e. WALL ANCHORAGE: Concrete walls, in-plane shear transfer from roof diaphragm to wall, and out of plane anchorage were retrofitted and provide load path. However, these connections do not meet current code requirements, and this is a well-documented potential failure connection. *See Images 2 & 11.*

Image 2: Wall Anchorage

RECOMMENDATION: Additional analysis and likely wall anchorage strengthening is recommended. Since the original retrofit was performed, this is a medium priority item.

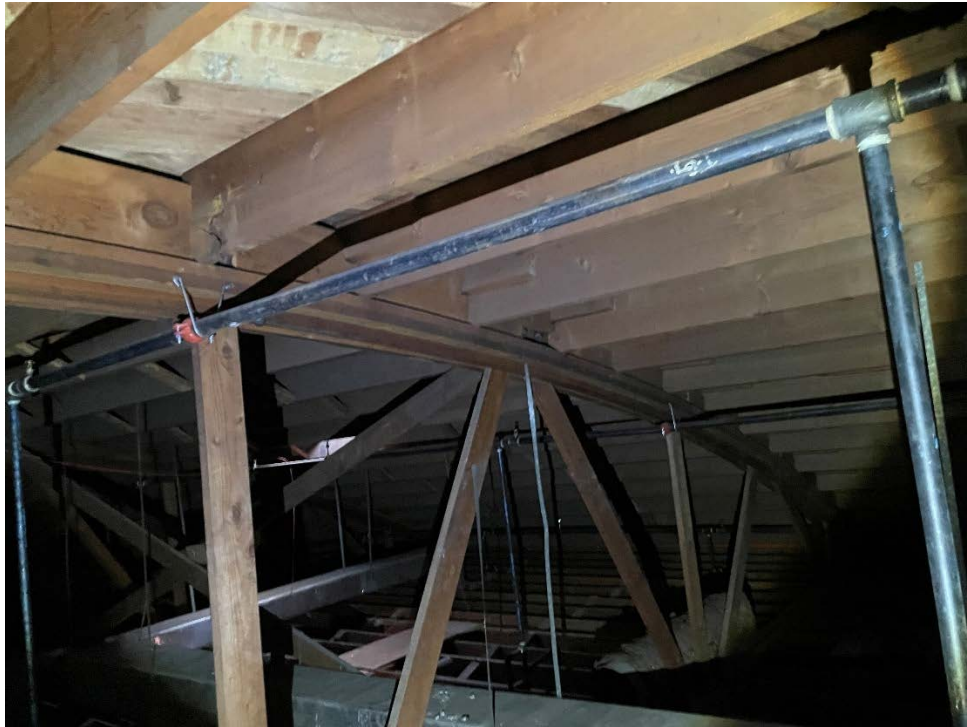
- i. ROOF TRUSSES: Bowstring roof trusses have historically exhibited connection failures. *See Image 3 & 4.*

Image 3: Bowstring Roof Trusses

RECOMMENDATION: Initiate and maintain a truss review plan to periodically observe trusses for connection issues. Limit modifications to or additional load being added to the existing roof trusses.

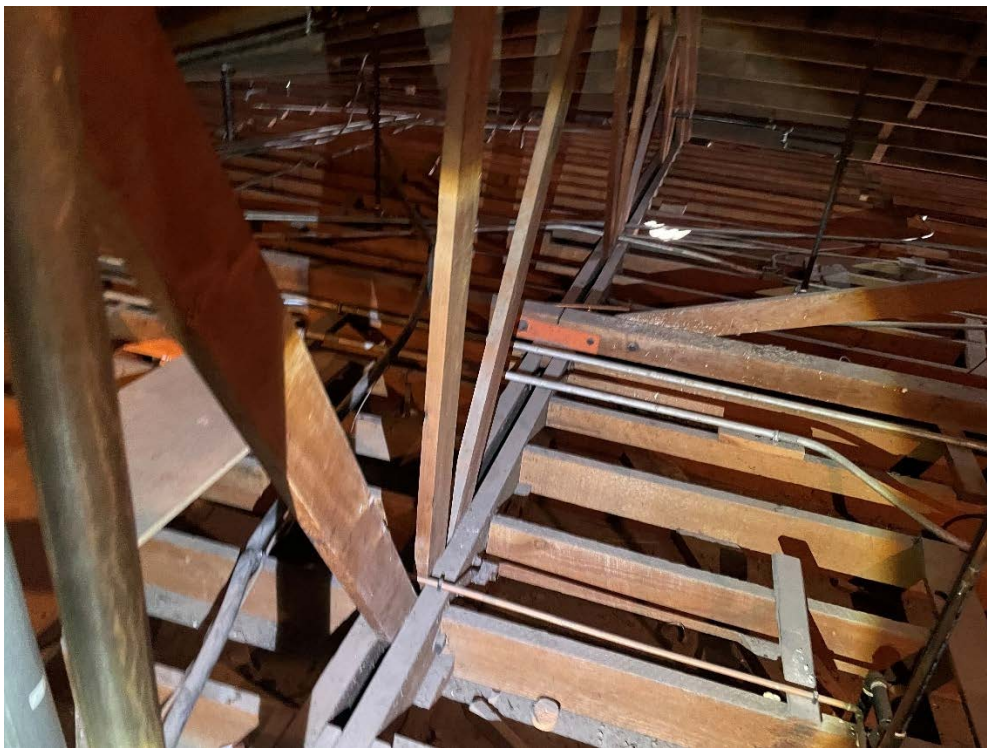
Image 4: Bowstring Roof Trusses

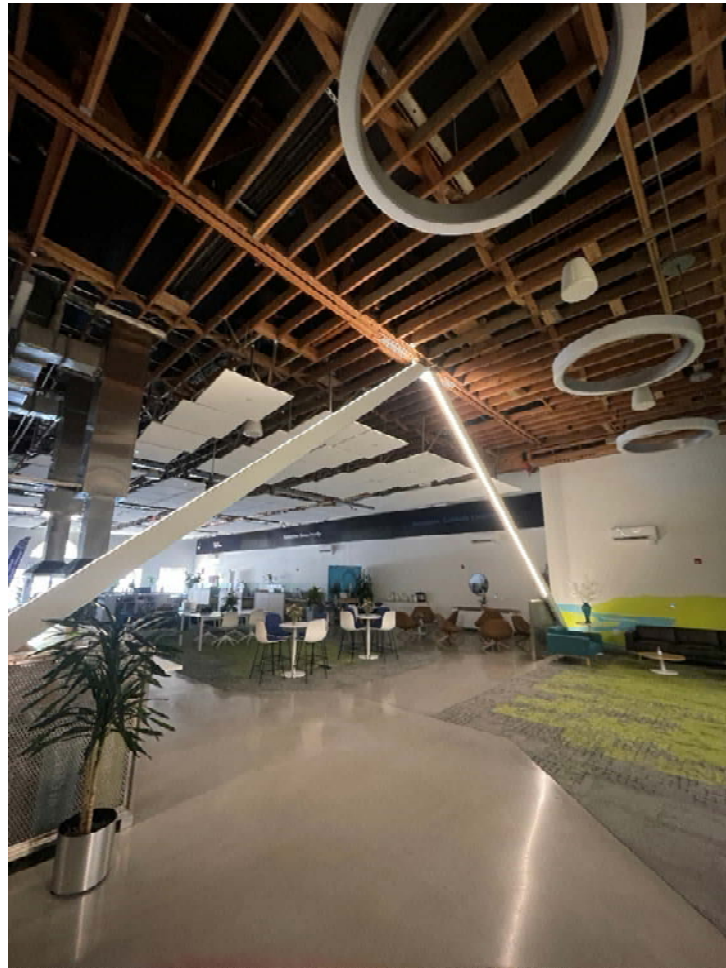
- f. SLENDERNESS OF DIAGONALS: Diagonal elements of brace frames do not meet current slender compression ratios. The bracing members are subject to buckling failures in a seismic event. *See Image 5.*

- g. NONCOMPACT MEMBERS: Brace elements do not meet moderately ductile requirements. *See Image 5.*

- h. CHEVRON BRACING: The beams in the chevron braces are not capable of resisting the vertical load from a yielding brace. The chevron brace configuration may induce large vertical loads on roof framing if a brace buckles/fails. *See Image 5.*

Image 5: Chevron bracing

RECOMMENDATION: Additional analysis and strengthening of the diagonal bracing members is recommended. This is a medium priority item.

RECOMMENDATION: See above. Add center columns at the middle of the brace frames to eliminate significant demand at the roof framing.

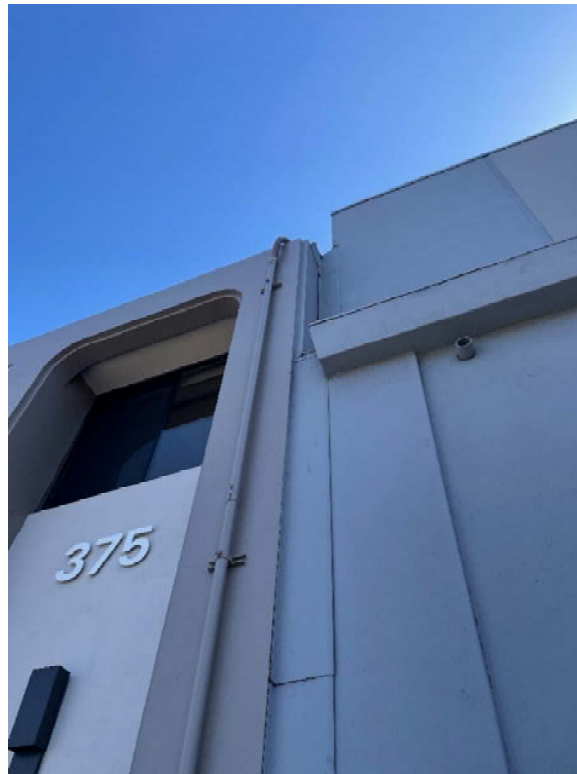
- d. **SEISMIC GAP:** Seismic gaps to adjacent buildings do not appear to be code compliant. The wall at the West end of the structure appears to be shared with the adjacent structure. Original drawings indicate post and beam construction against this wall. The roof parapet appears to be constructed with and braced to the adjacent building. The structure does have a seismic gap at the East end of the structure. The gap appears to be reasonable size for the height of the structures. *See Images 8 & 9.*

Image 8: Seismic Gap

**RECOMMENDATION:** Review connection details with West building in more detail. Some selective finish removal is likely required. This is a medium priority item.

As a low priority, at East building review drift requirements and pounding implications versus building stiffening requirements. To retrofit this would likely be very impactful and not cost effective.

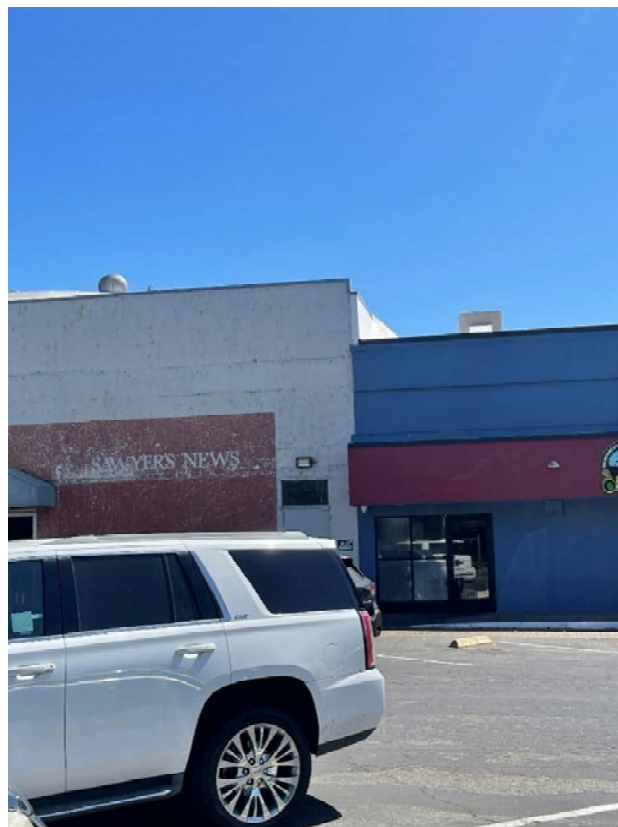
Image 9: Shared Wall at Adjacent Building – West Face

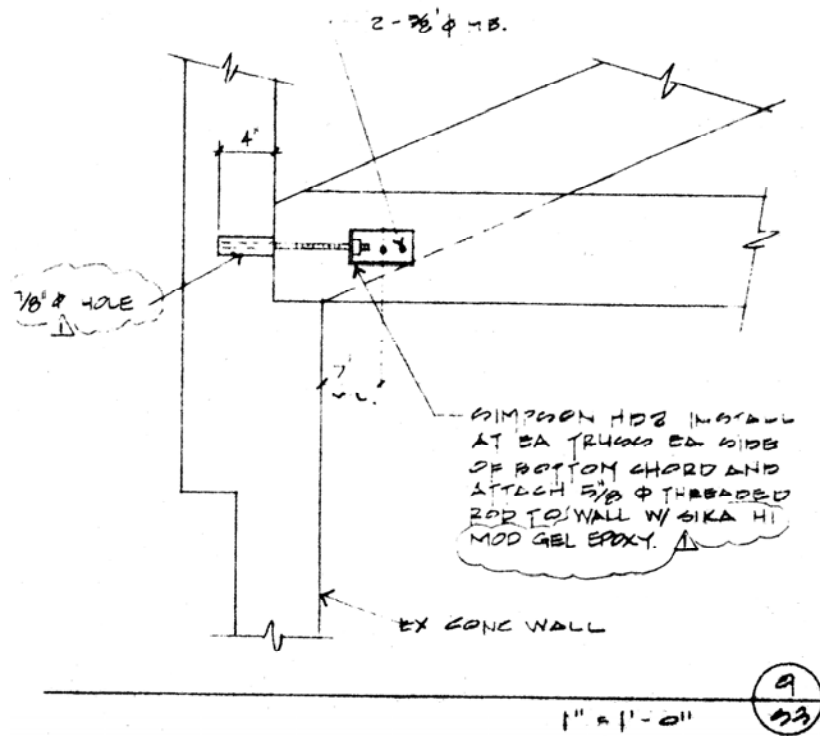
Image 11: Seismic Retrofit – Wall Anchorage

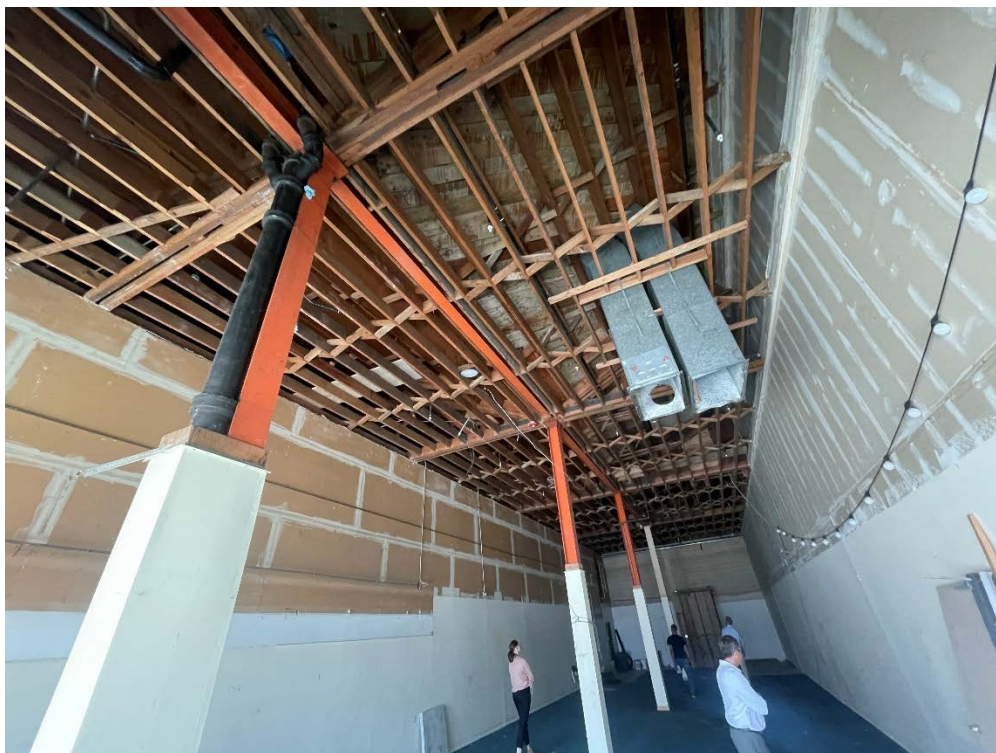
- j. DEMISING WALLS: The demising walls dividing the spaces were discovered to be non-bearing walls. *See Image 12.*

Image 12: Beam and Column line and Demising Non-Bearing Walls Each Side

RECOMMENDATION: No additional analysis required.
