**Subject: Roof Assessment and Budget Proposal for 741 4th Street**

# Inspection Report

RCGH, Inc.  
733 4th St  
Santa Rosa, CA 95404

## Silver Coated Capsheet

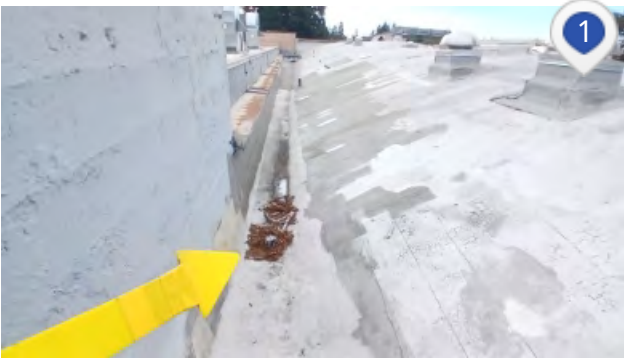
01m - Debris - Drains (Emergency)

Drains will be cleaned out. Debris hauled off, and disposed of

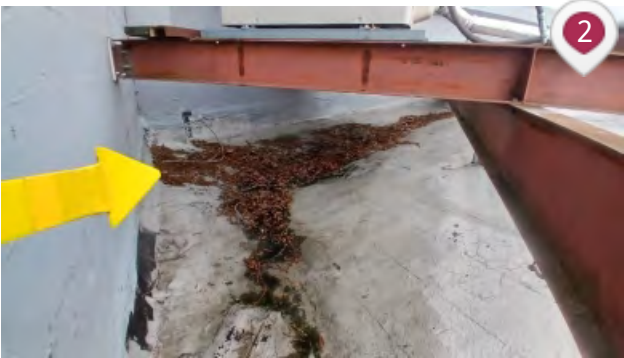
01n - Debris - Leaves (Emergency)

Leave debris can cause roof drains to plug and should be removed as part of a semi-annual maintenance program

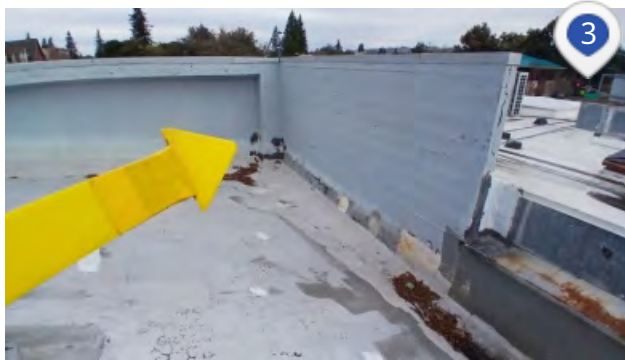
### 04a - Open Parapet Transition (Emergency)

Parapet transition is open, deteriorated or has a hole

Loose aluminum coating and heavy aluminum pigment should be removed completely and cleaned. Any wet areas must be removed and/or dried out before coating.

Repair all cracks, voids, or other surface imperfections in the roof field or flashing areas with acrylic mastic and polyester fabric. The polyester fabric shall extend 4-6 inches beyond the area in need of repair.

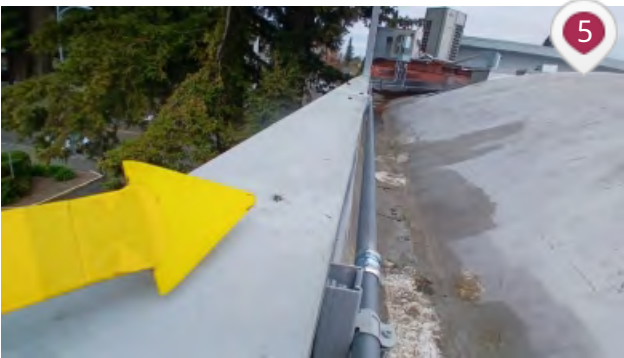
**03 - Fastener Backout (Emergency)**

Fasteners have backed out  
70 LF of cap metal is loose.
